SWEATING PIPES

The world-famous Petronas Twin Towers and the surrounding city centre utilises liquefied natural gas for power generation and utilities. These gas lines are cooled by chilled water and the insulated pipe lines run underground beneath the KLCC at the Twin Towers. The diameters of these pipes range between 12" and 48".

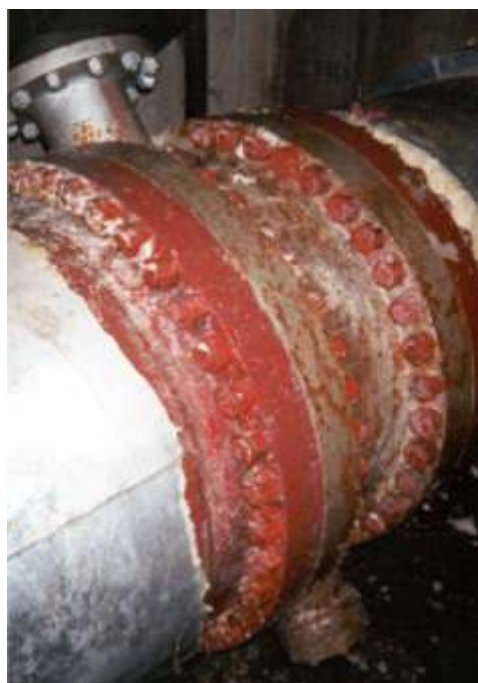
Despite being a relatively new installation, the jointing flange areas of the pipe lines were suffering from high levels of corrosion under the insulation jacket, through failure of the original coating in the extremely wet conditions produced by condensation in highly humid conditions.

Above: 32" flange after removal of insulation showing corrosion.

The pipelines were also difficult to access, as they are underground in a confined area, only accessible through manholes, so surface preparation and coating techniques were restricted to water jetting, hand abrading and brush application. After water jetting, flange surfaces were abraded using wet & dry sandpaper to create profile for adhesion.

Following abrading, all surfaces were washed down to remove contamination prior to the application of the first coat. An index coat of Alocit 28.15 Tropical Yellow was followed by a finishing coat of Alocit 28.15 Tropical Gray.

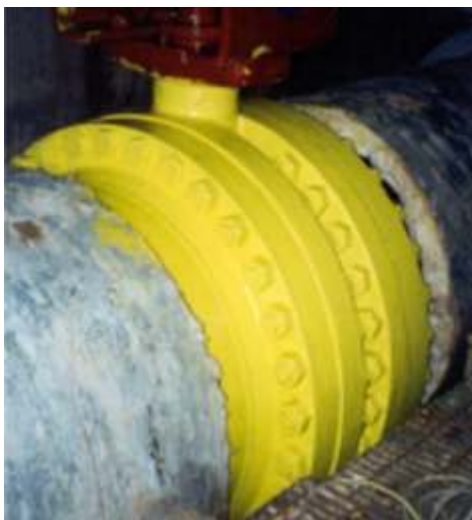
Above: Alocit 28.15 Tropical Yellow first 'index' coat.

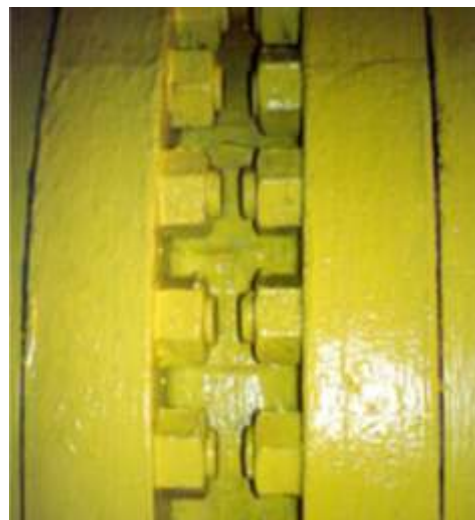
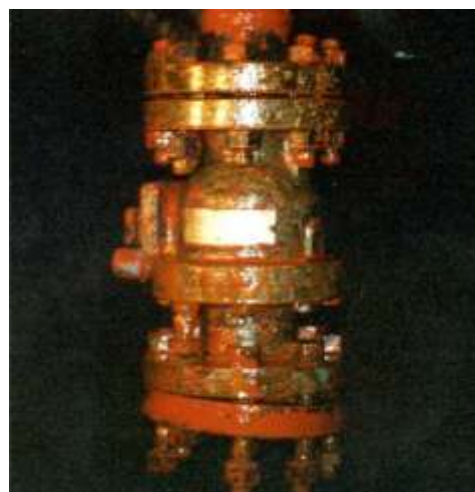
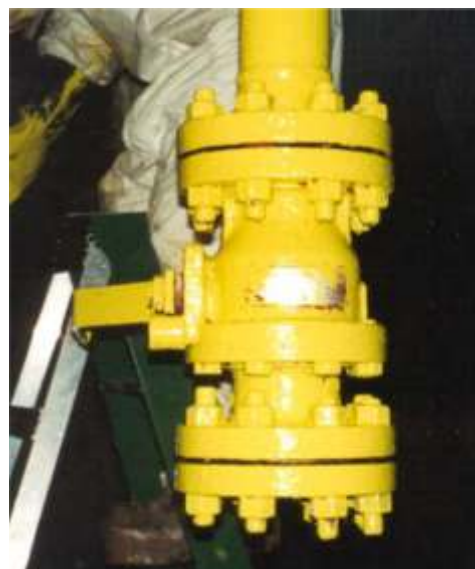
Right: Dripping wet and at risk from severe corrosion, these three inch flanges were also coated during the project.
